Manhole Inspection Summary

Manhole # S17AA1016MH

Insp Date: **2/28/07 2:33 PM**

Location Address: **2334 DRUID PARK RD**

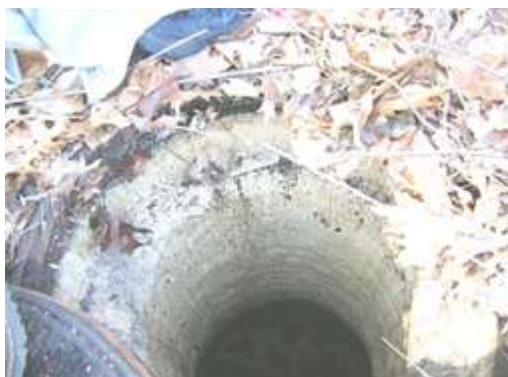
Defect

Frame Offset: **2** (in.) Condition: ☐ Sound ☐ Cracked ☒ **Leaks**

Infiltration: ☐ None ☒ **Joint** ☐ Cracks ☐ Mortar ☐ Roots ☐ Wall

Frame leaks. Frame offset. Adjustment infiltration.

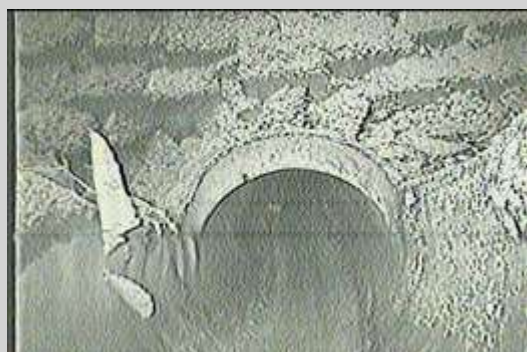
Pipe Out @ 12 O'Clock

Infiltration: **None**

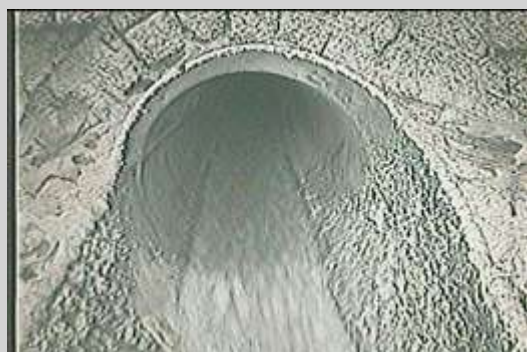
Pipe In @ 6 O'Clock

Infiltration: **None**
